Manhole Inspection Summary

Manhole # S19K1_031MH

Insp Date: **5/2/08 1:52 PM**

Location Address: **2517 marbourne av**

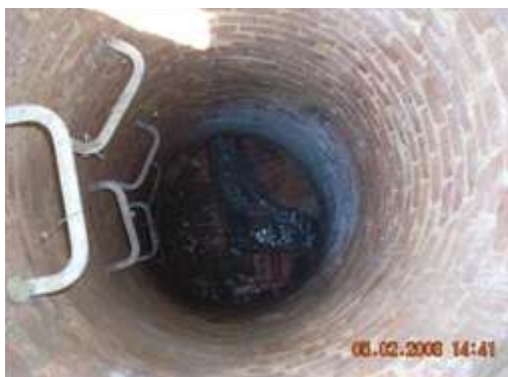
misc

bench debris

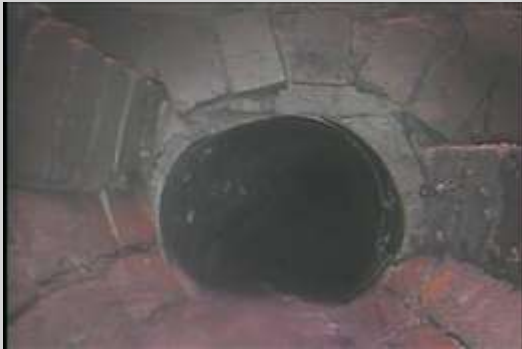
12 O'Clock Outflow

10 in. Circular Gravity Sewer
Pipe Out @ 12 O'Clock

Pipe Height: **9.6** (in.) Rod and Bar (Angled)
Pipe Material: **Clay** ☐ Pipe Lined
Invert Depth: **14.14** (ft.) Flow Characteristics: **Slow**
Deposits: ☒ None ☐ Mud ☐ Sludge ☐ Debris ☐ Grease
Silt Depth: **0** (in.) Deposits Extent:
Infiltration: **None** Pipe Seal Cond: **Broken**

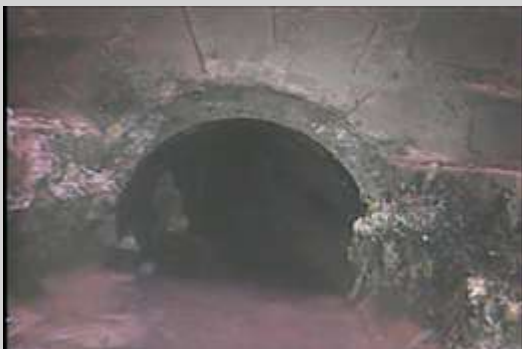
3 O'Clock Inflow

10 in. Circular Gravity Sewer
Pipe In @ 3 O'Clock

Pipe Height: **10.8** (in.) Rod and Bar (Angled)
Pipe Material: **Clay** ☐ Pipe Lined
Invert Depth: **14.00** (ft.) Flow Characteristics: **Slow**
Deposits: ☐ None ☐ Mud ☐ Sludge ☐ Debris ☒ Grease
Silt Depth: **1** (in.) Deposits Extent: **Light**
Infiltration: **None** Pipe Seal Cond: **Sound**
